30 June 2022

Study for Certification of Deferred Maintenance Project

**DCR Ellis Stone Storehouse
Hemlock Gorge Reservation
Newton, MA 02494**

**State Project #, Phase: P22-3481-S1A
CAMIS 'J' #: 601MDC9503
Agency Project #: P22-3481-S1A**

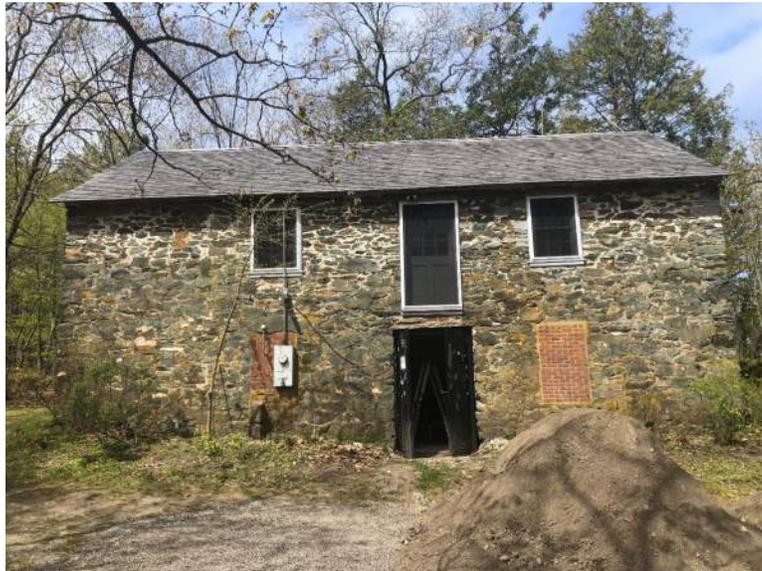
Photo 1: Overview of east elevation

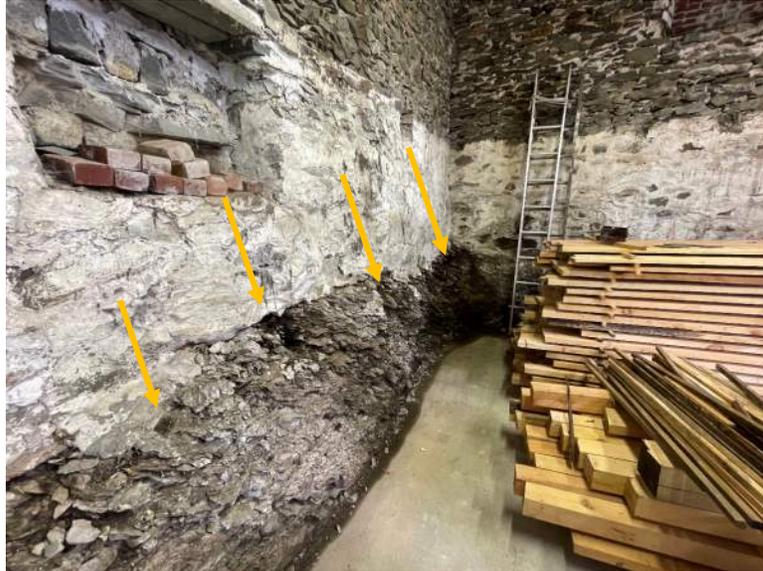
At portions of the west and north elevations, approximately 3-1/2 ft at the base of wall is an exposed natural ledge outcropping of Roxbury puddingstone (Photo 3). This natural ledge outcropping is below the exterior grade, and thus not visible from the exterior. The puddingstone is generally in poor condition, portions of the puddingstone are deteriorated, loose, and friable, and the puddingstone ledge is damp indicating water seepage from exterior to interior (Photo 4).

Photo 3: Roxbury puddingstone ledge outcropping at west elevation

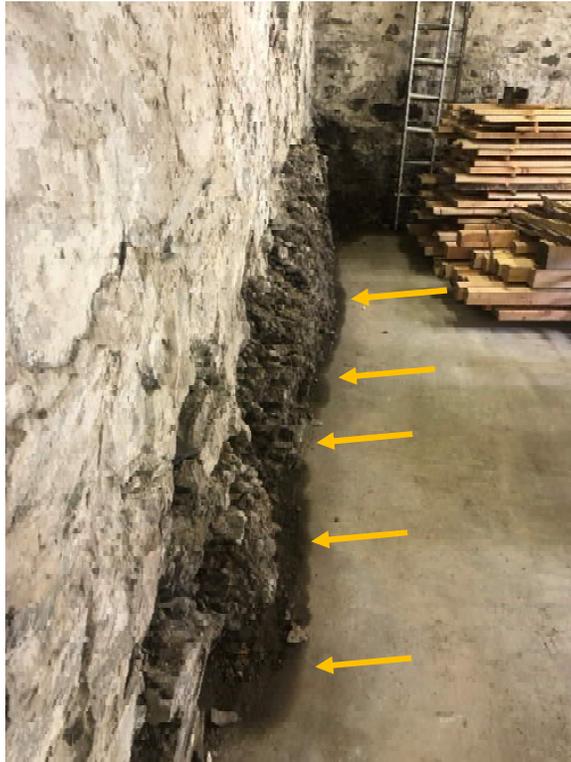
Photo 4: Moisture on floor at natural ledge outcropping along west wall

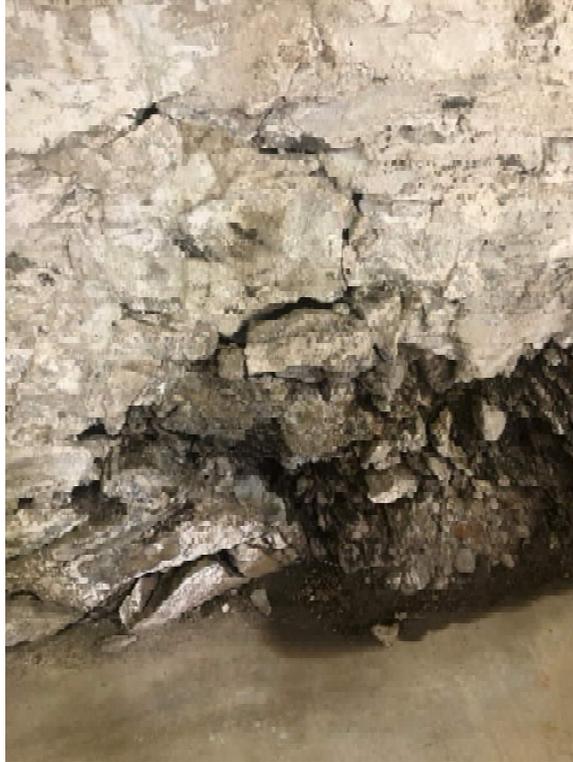
At one location, the rubble stone masonry above and adjacent to the puddingstone ledge appears to have settled. Portions of the wall directly above the ledge appear loose and are missing mortar and chinking (Photo 5).

Photo 5: Loose rubble stone masonry above puddingstone ledge

| Repair Type | Photo | Description | Interior or Exterior | Quantity | | | | Total from Condition Assessment | Total for Cost Estimate | Priority ¹ |
|---|--|---|---|---|---|---|---|---|---|---|
| P | | Remove loose stone and re-set, chinked tightly to adjacent intact stones with Type O mortar and new chinking as needed. Assume stone (basalt) obtained from nearby. | Interior | 0 sf | 0 sf | 0 sf | 40 sf | 40 sf | 50 sf | 1 |

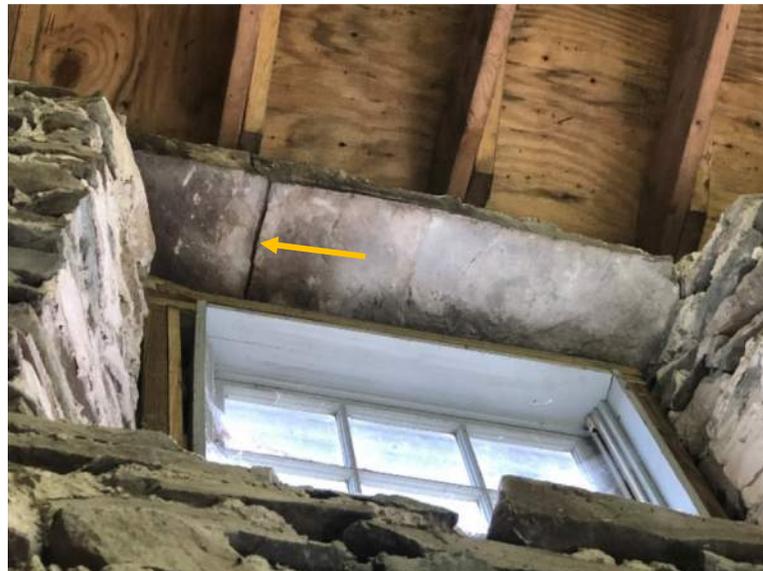
The stone lintels over the windows and doors are generally in good condition, with the exception of the two cracked lintels which are in poor condition (Photos 6, 7). These cracked stone lintels are present on the second-floor window and the entrance door on the east elevation.

Photo 6: Cracked stone lintel

| Repair Type | Photo | Description | Interior or Exterior | Quantity | | | | Total from Condition Assessment | Total for Cost Estimate | Priority ¹ |
|---|--|---|---|---|---|---|---|---|---|---|
| J Repair Cracked Lintels | | Shore lintel as required. Remove cracked lintel portion and square off remaining stone. Provide replacement lintel portion, 1/4 in. min. diameter s.s. spring anchors (2 per replacement block), and Type O mortar to match color, texture, and profile of existing stone. | Exterior | 0 | 2 | 0 | 0 | 2 ea | 3 ea | 1 |

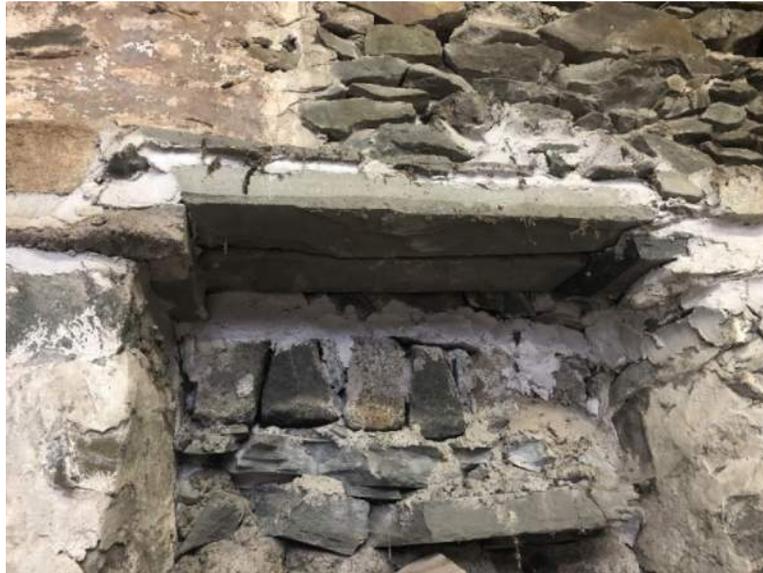
Two stone lintels were previously replaced, one with stone (Photo 7) and another with steel (Photo 8). The replaced lintels are in good condition.

Photo 7: Lintel replaced with stone

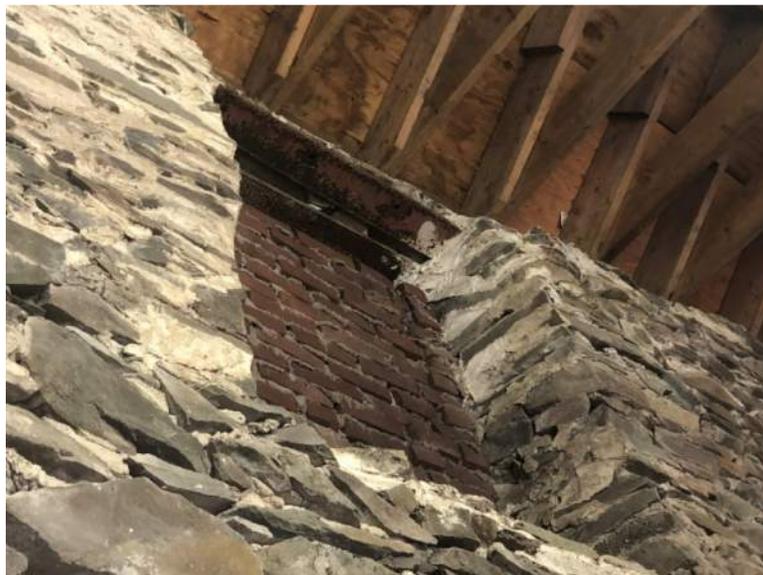
Photo 8: Lintel replaced with steel.

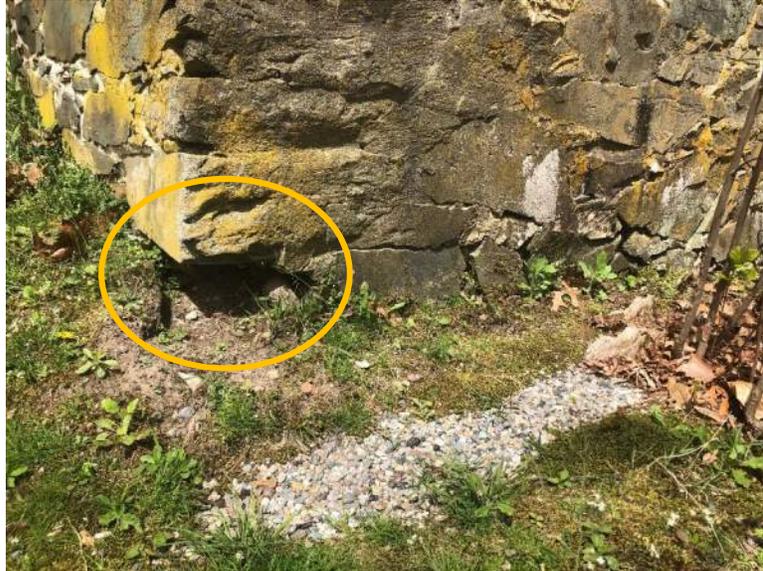
The cornerstone at the base of the wall at the southeast corner of the building is missing, reducing the gravity support for the rubble stone masonry wall above (Photo 9).

Photo 9: Missing cornerstone

| Repair Type | Photo | Description | Interior or Exterior | Quantity | | | | Total from Condition Assessment | Total for Cost Estimate | Priority ¹ |
|---|---|---|---|---|---|---|---|---|---|---|
| H Replace Blocks | | Replace blocks where missing. Assume stone (basalt) obtained from nearby. | Exterior | 0 | 1 | 0 | 0 | 1 ea | 2 ea | 1 |

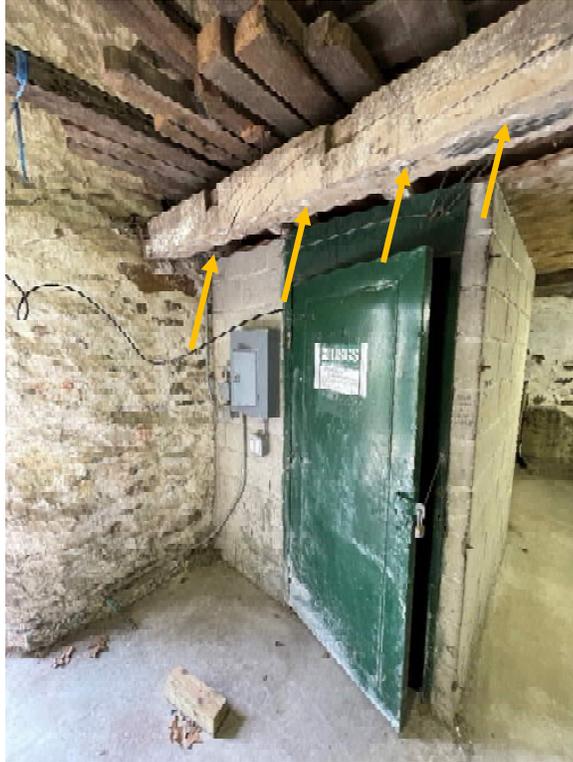
The northern portion of the second-floor wood framing has been removed. Many of the second-floor framing members on the south side remain, but the floor decking and some of the framing members have been previously removed. This is consistent with the observations from the 1989 MDC report. The remaining framing members are checked, but generally in fair condition (Photo 10). The rubble stone masonry at the framing pockets is often cracked or loose, reducing the gravity support for the wood framing members (Photo11). We see no visible indications that the previous removal of the second-floor framing in the northerly half of the building has adversely affected the exterior masonry walls. The remaining second-floor loft in the southerly portion of the building currently serves as storage for salvaged structural wood members.

Photo 10: Checked second-floor wood framing

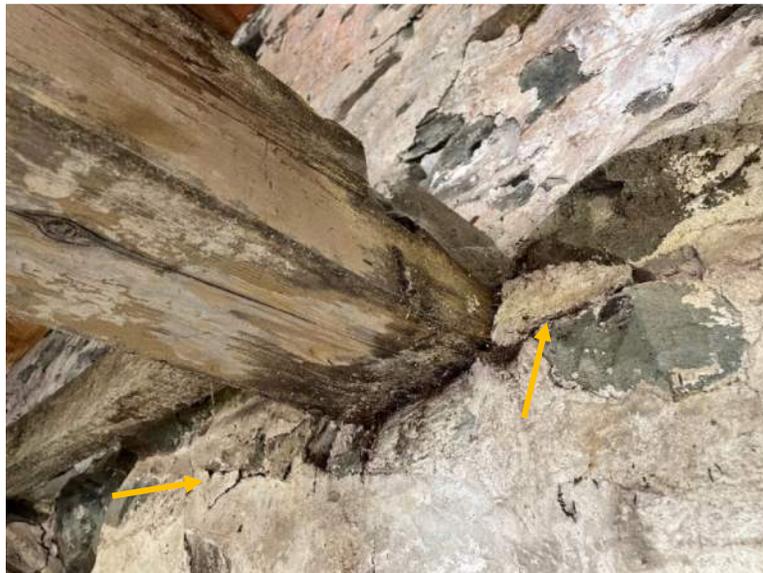
Photo 11: Cracked and loose rubble stone masonry at floor framing pocket

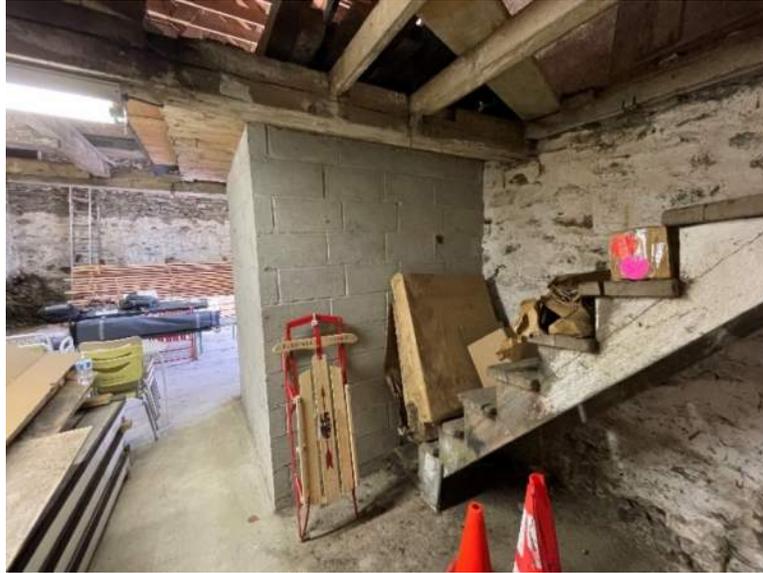
The existing stairs have been partially removed at the bottom of the run to accommodate the concrete masonry unit closet for the electrical equipment for monitoring the dam (Photo 12), thus creating a high first riser and narrow landing area that impede use of the stair.

Photo 12: Stairs to *second-floor* storage loft

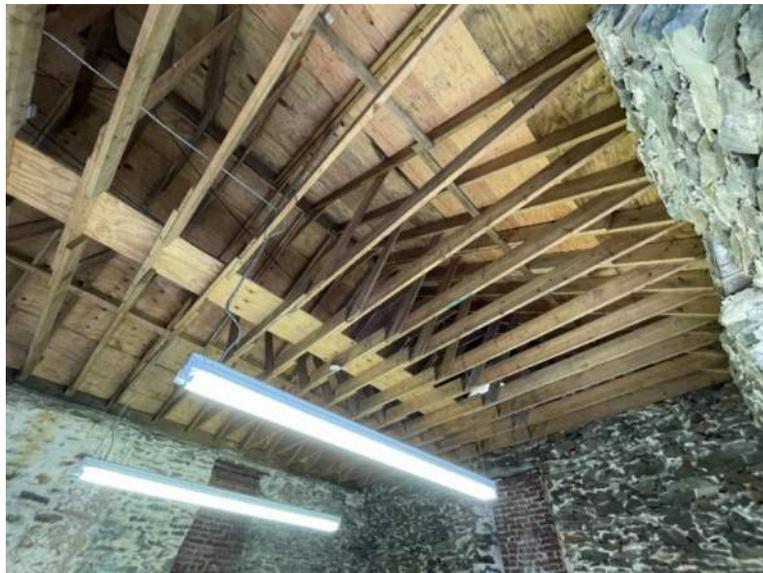
The original roof framing and sheathing appears to have been replaced relatively recently with new wood trusses and plywood sheathing (Photo 13). The roof framing and sheathing appears in good condition looking up from below.

Photo 13: Roof framing and sheathing

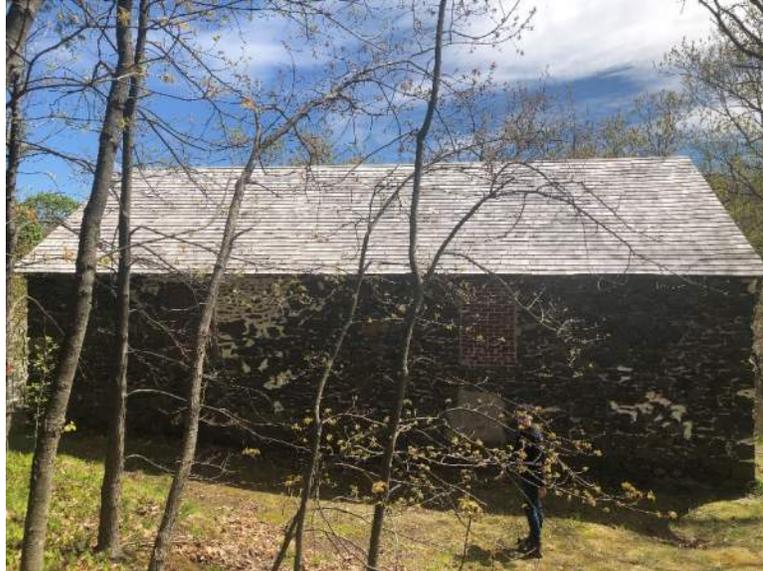
The cedar shingle roofing appears in good condition from the ground (Photo 14). We understand the roofing was installed relatively recently.

Photo 14: Cedar shingle roofing (view from west)

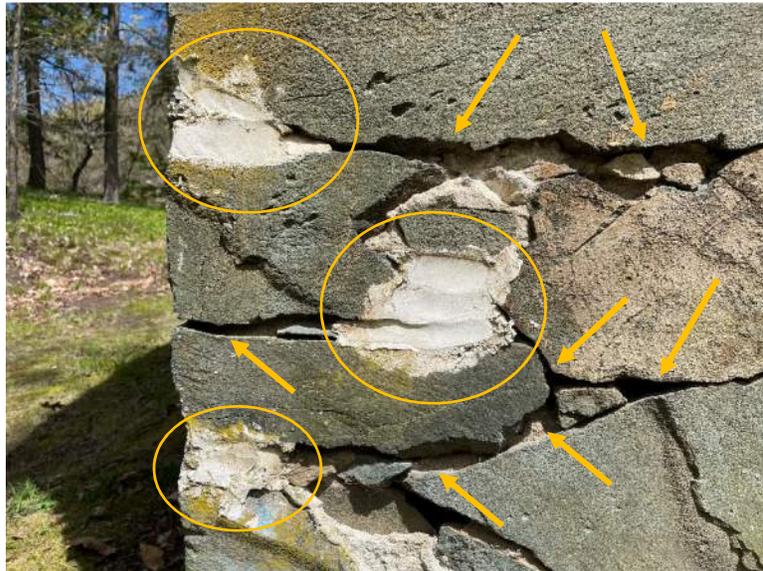
- Localized areas of severely eroded mortar. At some locations, the relatively recent white mortar has been installed and appears to have been applied by hand, with finger marks visible at some locations (Photo 15). This relatively recent mortar is bright white and does not match the remaining existing mortar in color, texture, or profile.

Photo 15: Severely eroded mortar (arrows) and non-matching replacement mortar (circled)

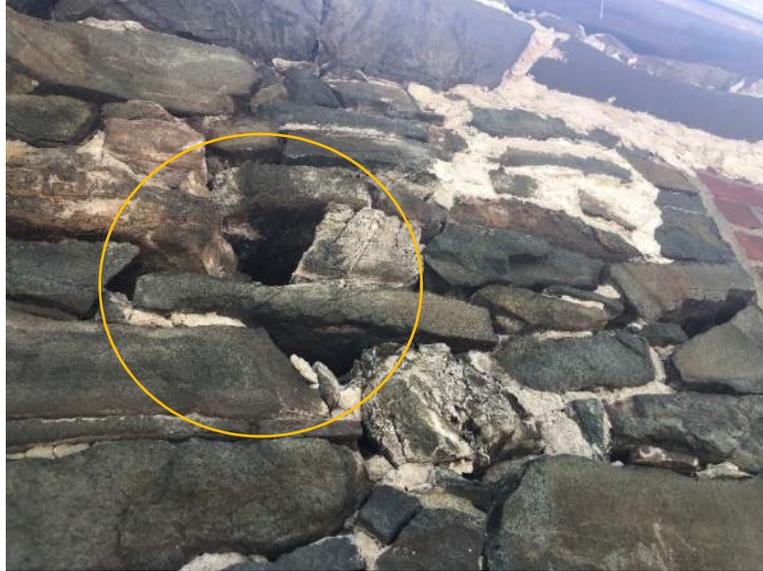
- Localized areas of missing chinking (smaller in-fill stones) between the larger rubble stones (Photo 16). The voids at missing chinking can allow bulk water intrusion into the core of the

load-bearing masonry walls, as well as to the building interior. Additionally, the missing chinking means a loss of point-to-point contact between surrounding stones and creates a point where displacement (movement) of stones can more easily occur as water enters and mortar deteriorates.

Photo 16: Missing chinking in exterior stone masonry

| Repair Type | Photo | Description | Interior or Exterior | Quantity | | | | Total from Condition Assessment | Total for Cost Estimate | Priority ¹ | |
|---|---|--|---|---|---|---|---|---|---|---|---|
| D | Replace Chinking | | Replace chinking where missing or where large pockets of mortar would be required. Assume stone (basalt) obtained from nearby. | Exterior | 5% | 5% | 5% | 5% | 5% | 5% | 2 |

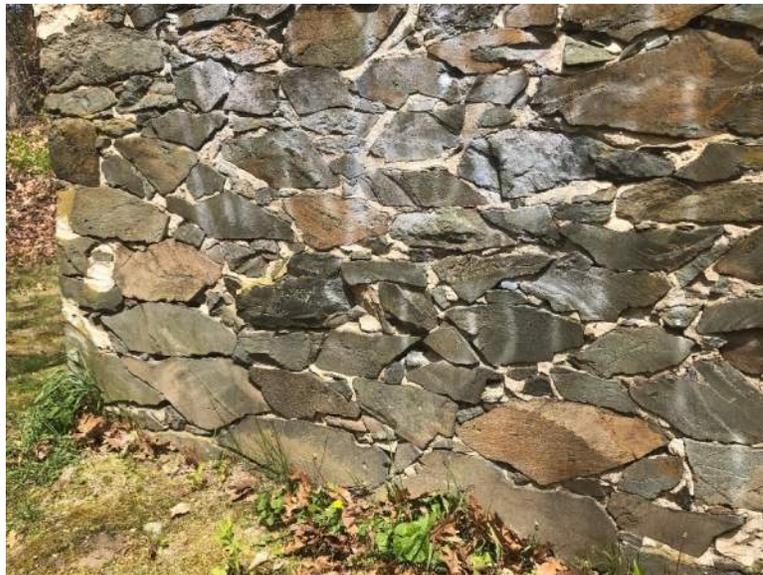
- Localized graffiti on masonry (Photo 17).

Photo 17: Graffiti

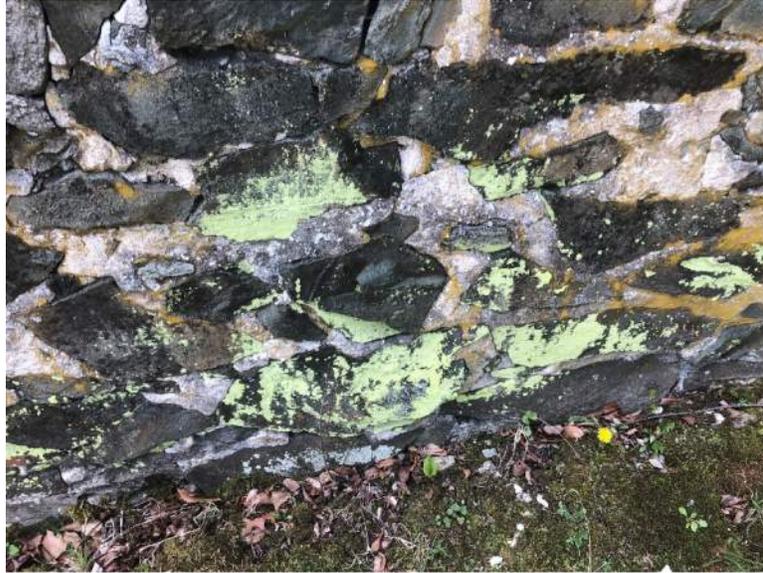
- Biological growth, staining, and efflorescence on surface of rubble stone masonry (Photo 18).

Photo 18: Biological growth and staining

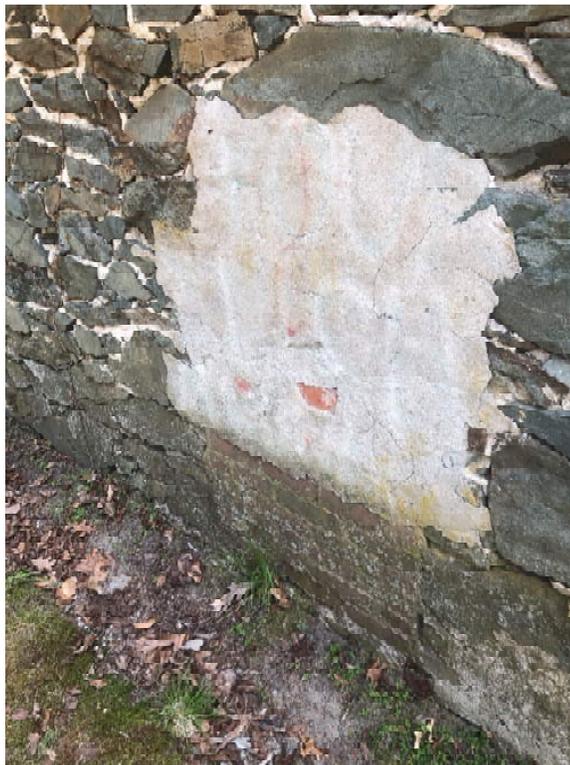
- One location on the west elevation where an exterior parge coat (i.e., render) is installed over the rubble stone masonry and brick infill (Photo 19). The parge coat is cracked and delaminated.

Photo 19: Parge coat at west elevation

| Repair Type | Photo | Description | Interior or Exterior | Quantity | | | | Total from Condition Assessment | Total for Cost Estimate | Priority ¹ |
|---|--|---|---|---|---|---|---|---|---|---|
| I Remove Parge Coat | | Remove delaminated parge coat from face of stone/brick. | Exterior | 0 sf | 0 sf | 0 sf | 15 sf | 15 sf | 15 sf | 3 |

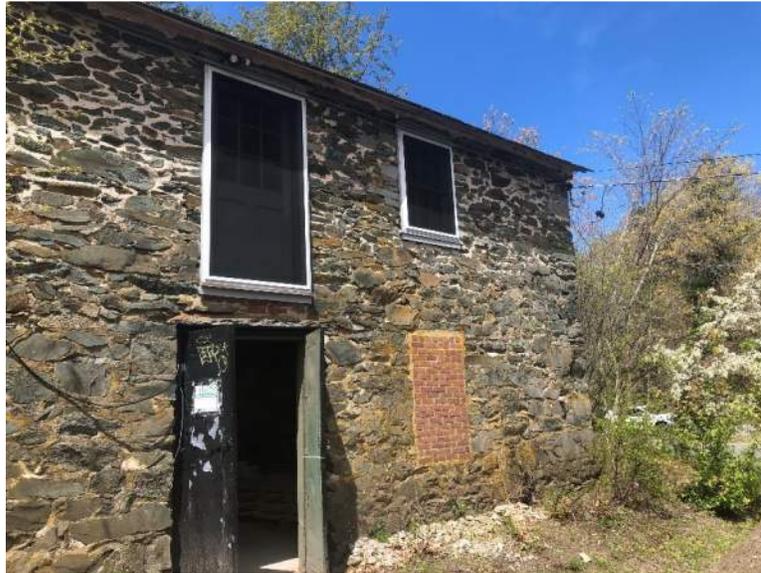
The majority of the windows have been infilled with brick masonry. A small portion of the opening in the rubble stone above the entrance door has also been infilled with brick. At the east elevation, the second-floor windows and door have recently been replaced; the windows are covered with screens with historically incongruous white aluminum frames (Photo 23) that project forward past the face of the stone masonry walls. The attic windows have not been infilled but are open or filled with a wood frame and screen.

Photo 23: Brick infill and replacement window and door

| Repair Type | Photo | Description | Interior or Exterior | Quantity | | | | Total from Condition Assessment | Total for Cost Estimate | Priority ¹ |
|---|---|---|---|---|---|---|---|---|---|---|
| N | Remove Brick Infill and Install New Windows | <p>Remove and replace existing windows and door on east elevation. Remove brick infill from window openings and install new 6 over 6 double hung windows with heat-strengthened laminated glass and wood shutters. Do not install insect screens. Install windows at small openings not infilled on north and south elevations.</p> | Exterior | 2 | 5 | 3 | 4 | 14 ea | 14 ea | 3 |

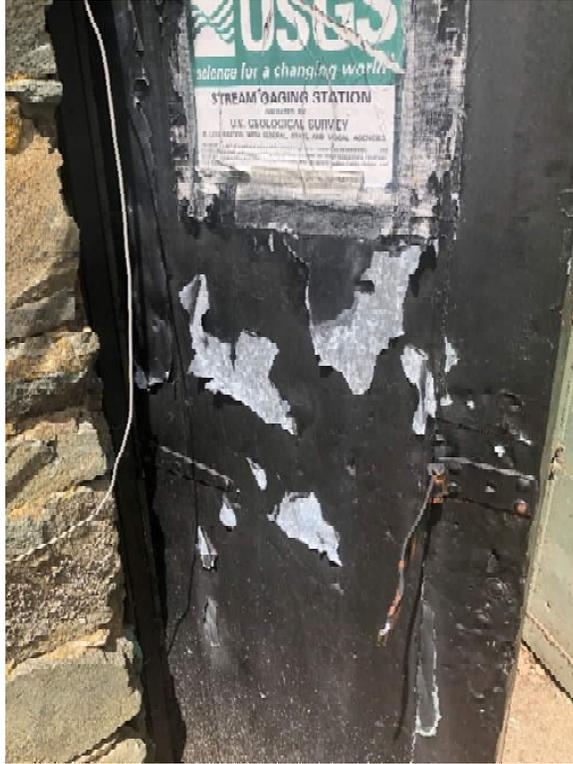
The galvanized steel-clad entrance door at the east elevation is in fair condition. The door is historically incongruous, and the paint is peeling (Photo 24).

Photo 24: Peeling paint on galvanized steel entrance door

| Repair Type | Photo | Description | Interior or Exterior | Quantity | | | | Total from Condition Assessment | Total for Cost Estimate | Priority ¹ |
|---|---|---|---|---|---|---|---|---|---|---|
| M | Replace Door | <p>Remove and replace door with historically appropriate wood door (cedar or sim.)</p> | Exterior | 0 | 1 | 0 | 0 | 1 ea | 1 ea | 3 |

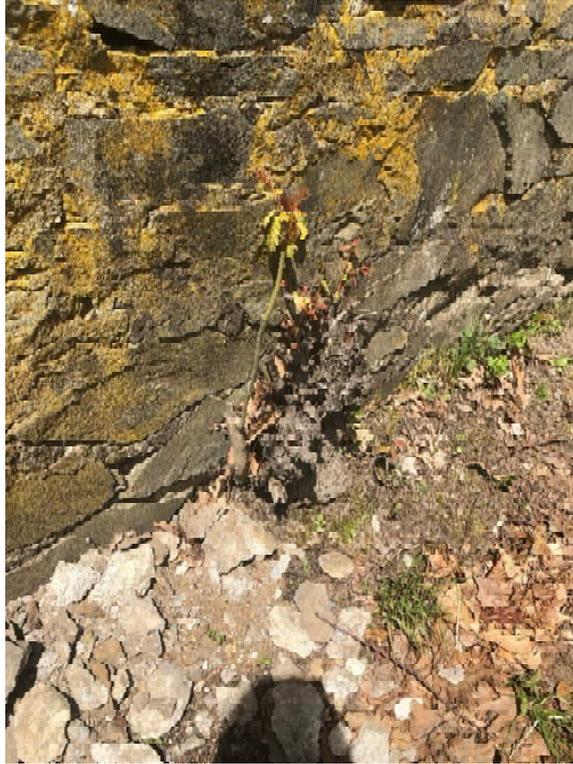
We observed vegetation directly abutting the building and within a couple feet of the face of the building (Photo 25). Large roots from vegetation can damage the stone masonry.

Photo 25: Woody vegetation directly abutting the building

| Repair Type | Photo | Description | Interior or Exterior | Quantity | | | | Total from Condition Assessment | Total for Cost Estimate | Priority ¹ |
|---|---|---|---|---|---|---|---|---|---|---|
| G Remove Vegetation | | Remove large vegetation within 3 ft of the building face. | Exterior | 22 lf | 40 lf | 22 lf | 40 lf | 124 lf | 125 lf | 1 |

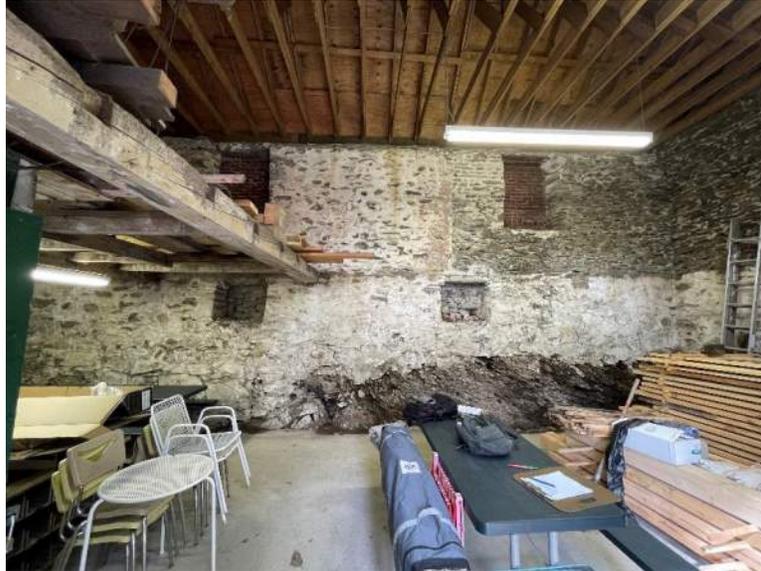
The interior floor is concrete, and the visible floor appears to be in good condition. Portions of the floor were covered with stored materials (e.g., lumber, picnic tables, etc.) at the time of our visits (Photo 27).

Photo 27: Interior concrete floor slab

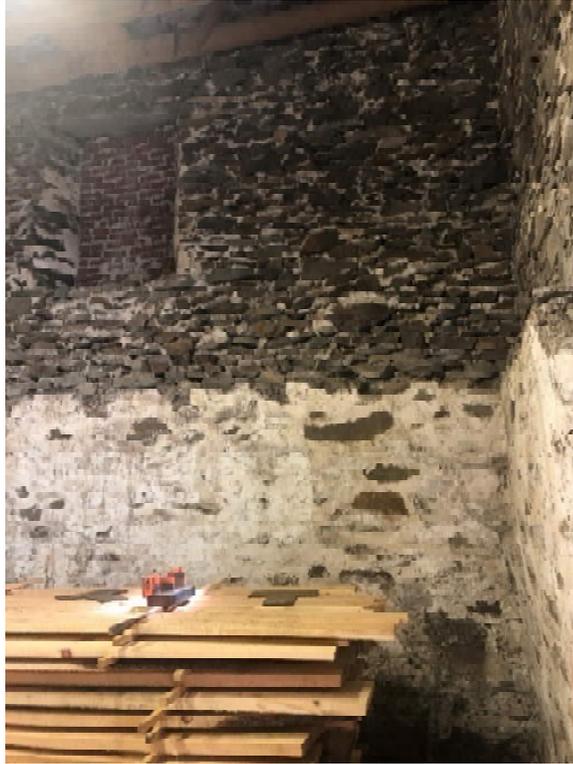
The interior surface of the walls is partially rendered over the rubble stone masonry (Photo 28). The render (plaster directly applied and bonded to the masonry, without lath or furring) is not present at the second floor at the northern end of the building. The interior of the walls is generally in relatively good condition.

Photo 28: Interior walls are partially rendered (lower portion of photo)

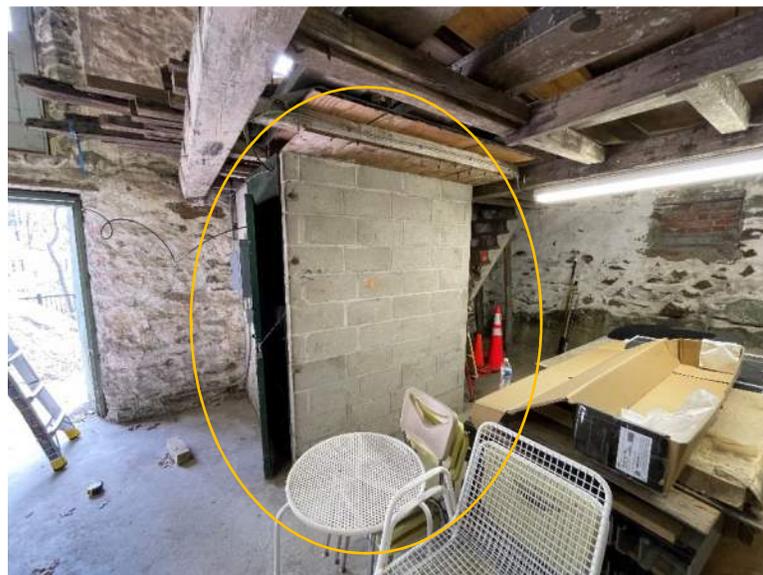
Near the entry door, we observed a utility closet constructed with concrete masonry unit (CMU) partition walls (Photo 29). The closet appears to contain the water level monitoring equipment for the nearby Charles River, just above the dam. Multiple conduits from the exterior run to this closet, through a brick-infilled window and gaps at the entrance door surrounds.

Photo 29: CMU closet containing water level monitoring equipment

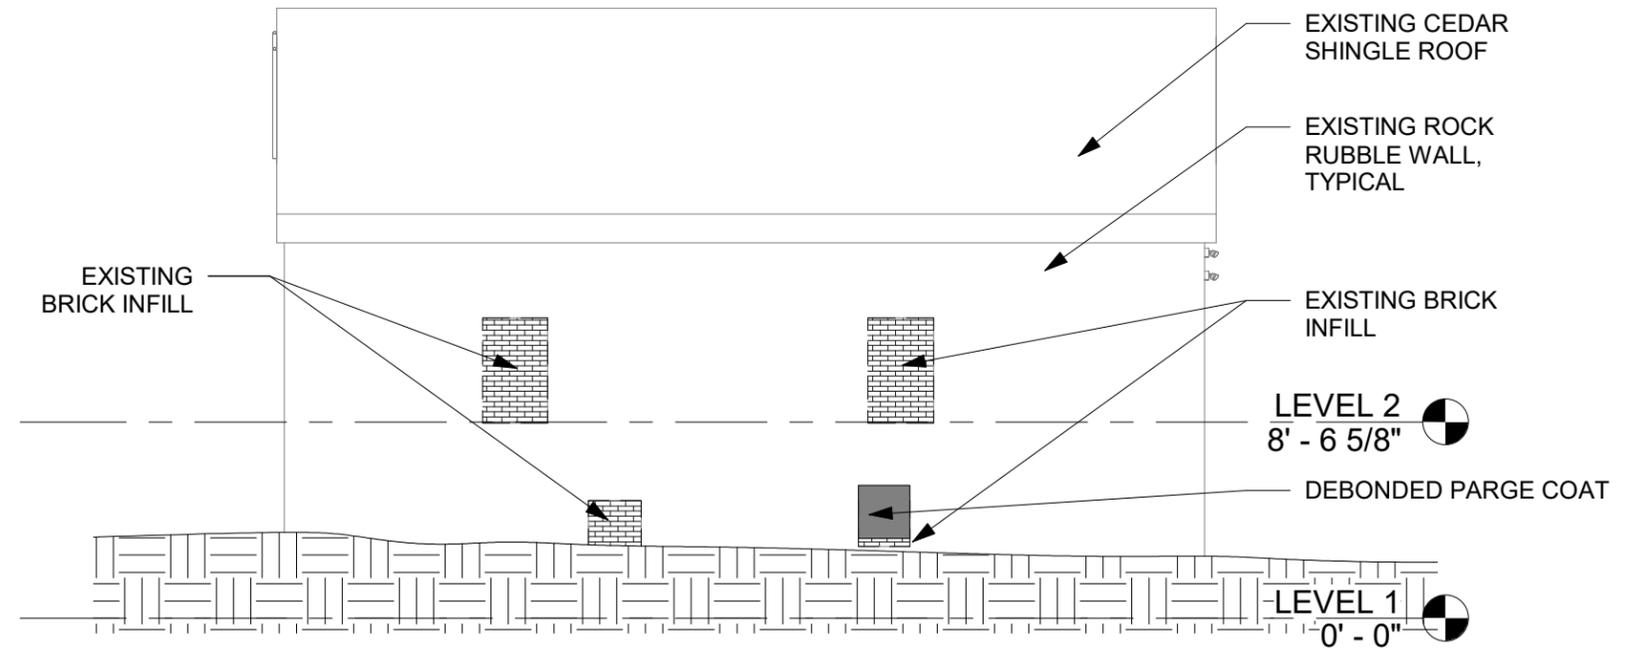
4 WEST ELEVATION
1/8" = 1'-0"

NOTE: ALL MORTAR ON WEST ELEVATION IS SEVERELY ERODED.
