ECHO BRIDGE SAFETY IMPROVEMENT PROGRAM
MWRA CONTRACT No. 6988
TASK ORDER No. (18)

Historic Cast Iron and Steel Railings Report
Newton Upper Falls – Needham, Massachusetts
Prepared for the Massachusetts Water Resources Authority

September 2007

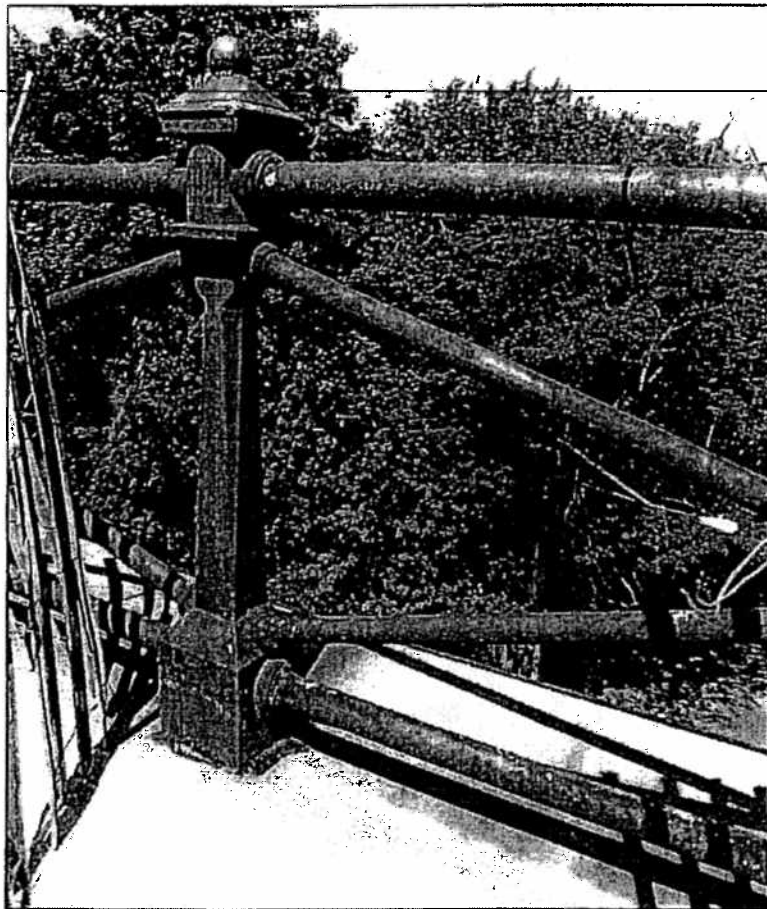
Typical Bridge Post and Rail

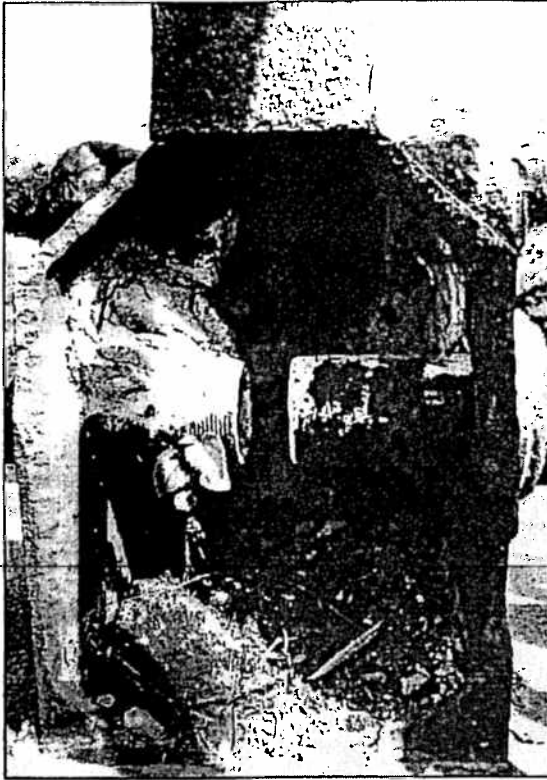
Spalling Cast Iron at Post Base

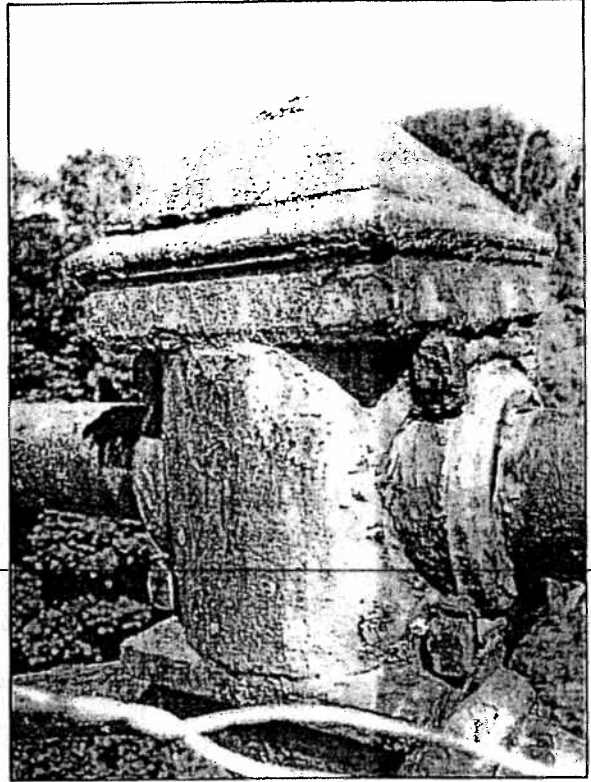
Inappropriate Repairs and Eroded Paint

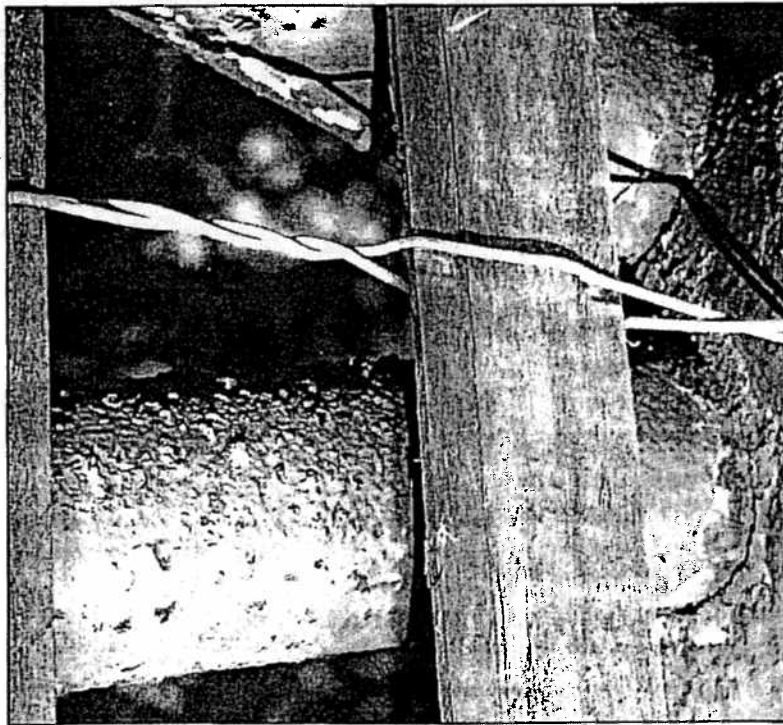
Paint Blistering and Rail Joint Failure at Rosette

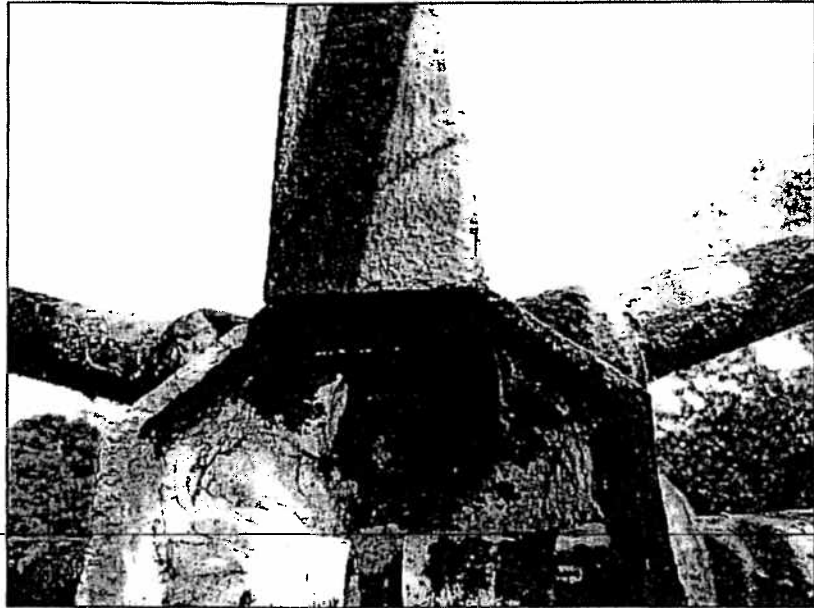
Overly Thinned Post Section

inch thickness. In general, when the wall thicknesses in cast iron posts are less than 3/8 inches there is a marked reduction in their ability to adequately resist the forces of corrosion and ice jacking. The historic cast iron posts were originally secured to the deck with a threaded rod embedded in the granite deck that ran to the top of the post and was secured by a threaded spherical cap. Originally these caps would have been securely tightened to hold the post to the deck. The threaded steel rod was much more susceptible to corrosion than the surrounding cast iron posts. In general, where the cast iron post is broken, this rod is missing or rusted through. Rather than replacing these threaded rods, an attempt was made to stabilize the post by adding a cementitious grout. The grout in the post cavity ranged from a few inches to filling of the entire post. This repair attempt has greatly accelerated the deterioration of the posts by trapping moisture and providing a surface for ice jacking. Typically, the ball caps are now welded to the posts.

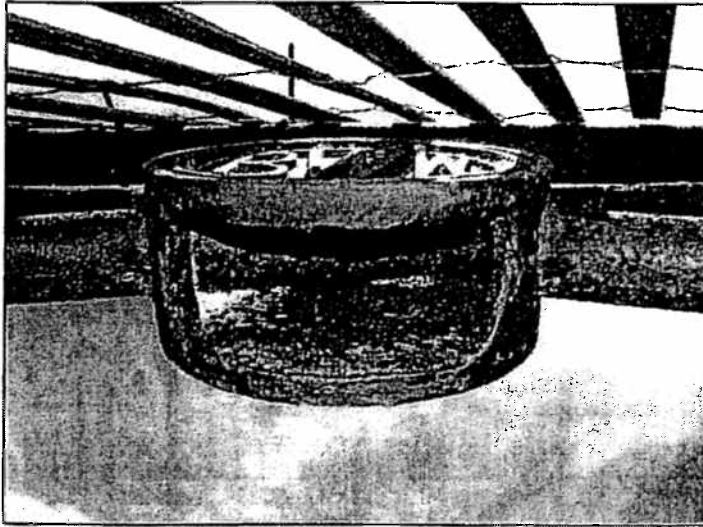
Cast Iron Spalling at Rosette

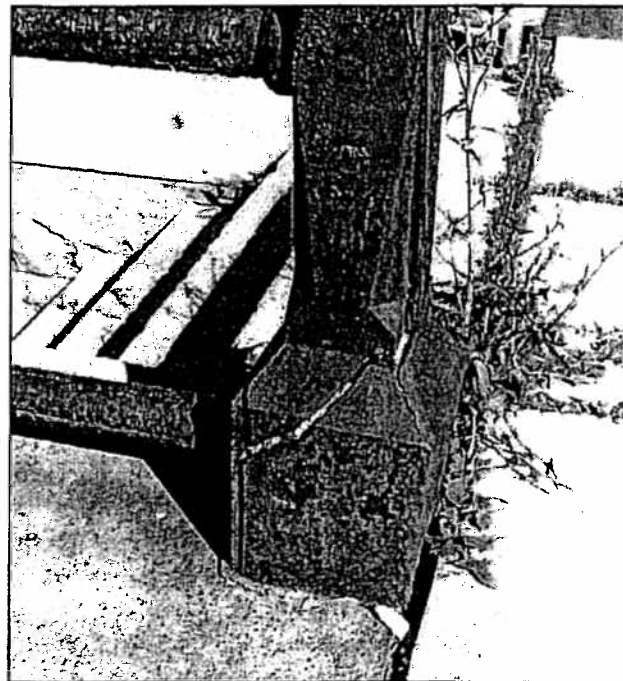
The most serious issue with both of these railing systems is the deteriorated condition of the posts due to widespread cracking, rusting and spalling. More than 48% of the bridge and 60 % of the landing posts have severe cast iron breakage. These damaged posts are beyond repair and will need to be recast. Eighteen percent of the bridge and 20% of the remaining landing finials on top of these posts are missing and half of the remaining ones are different sizes.

Fractured Post

Recommendation: The entire system will need to be disassembled and some detailing revised to allow greater expansion and contraction to take place and to prevent failure to the new cast iron posts. A post-by-post interior inspection did not take place as part of this work, which may reveal further deterioration on additional posts when construction work begins.

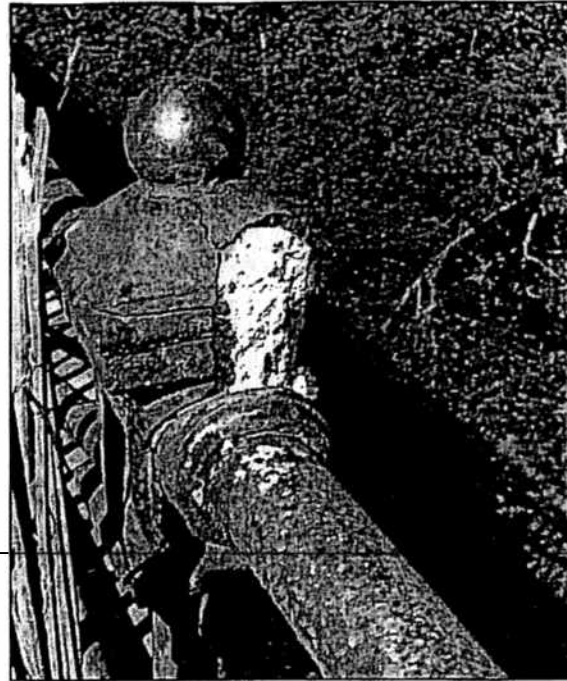
In examining the cast iron posts with broken sections, 38% of the bridge and 57% of the landing posts have been filled with a cementitious grout composed of a sand and cement mixture. All these posts show severe vertical cracking from the top rail to the base as well as spalling. The grout shrinks after it has filled the cavity and acts as a water collector. When water penetrates the inside of the post it fills the voids and freeze-thaw cycles take place, resulting in ice jacking. Cast iron is weak in tension. Ice expansion and wedging (ice jacking) create stress-relieving cracks and breaks in the cast iron.

Spalling at Post Cap Due to Grouting of Post and Ice Jacking
