30 June 2022

Study for Certification of Deferred Maintenance Project

**DCR Ellis Stone Storehouse
Hemlock Gorge Reservation
Newton, MA 02494**

**State Project #, Phase: P22-3481-S1A
CAMIS 'J' #: 601MDC9503
Agency Project #: P22-3481-S1A**

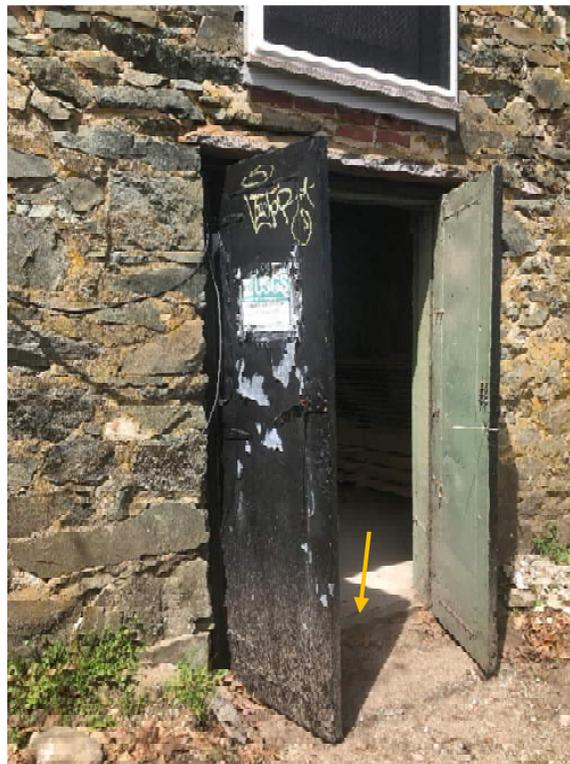
The interior of the Ellis Storehouse is accessed via the double outswing entry doors on the east elevation (Photo 2). The interior floor slab is several inches higher than the exterior grade, creating a vertical offset that is significantly greater than the 1/4 in. maximum allowed by accessibility codes.

Photo 2: Entry door with vertical offset from exterior to interior (arrow)

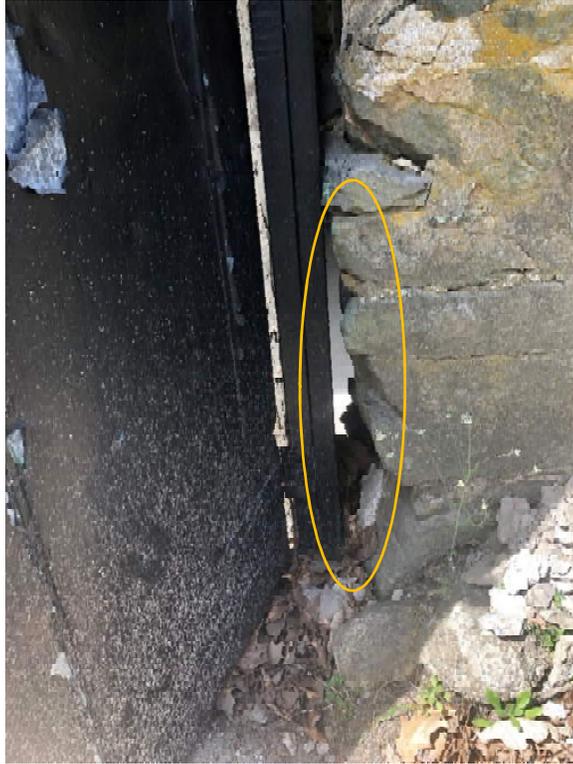
- Gaps at door surrounds (Photo 20) and between exterior wall and roof framing. These gaps can allow pests (e.g., rodents) to enter the building.

Photo 20: Gap at door surrounds

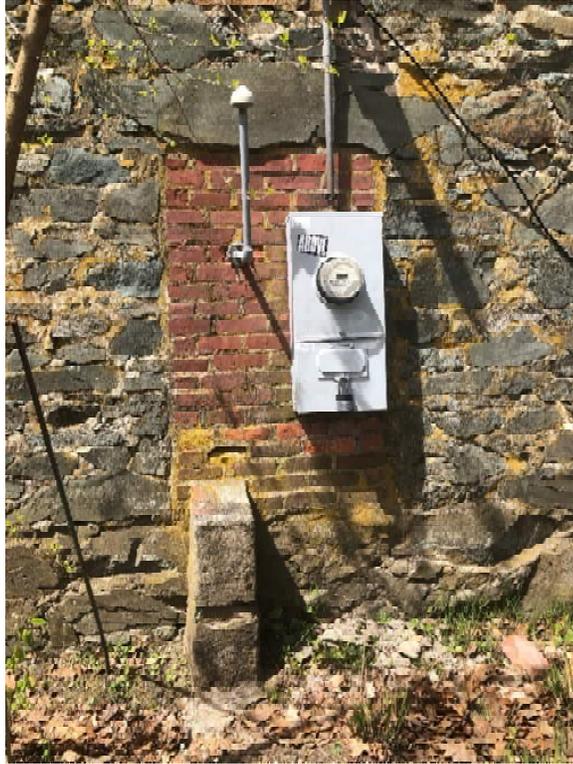
- Multiple locations of electrical equipment and conduits fastened to, penetrating through, and marring the historic appearance of the exterior masonry walls (Photo 21).

Photo 21: Electrical equipment and conduits attached to, penetrating through, and marring the historic appearance of the exterior masonry walls

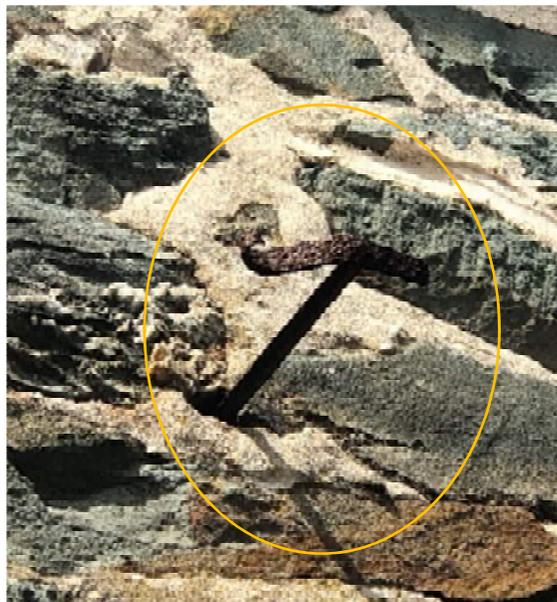
- Abandoned ferrous metal shutter tie-back hardware is present on the east elevation, indicating the building once had functioning shutters. (Photo 2). This is consistent with the early 20th century photographs included in the MDC report.

Photo 22: Shutter tie-back

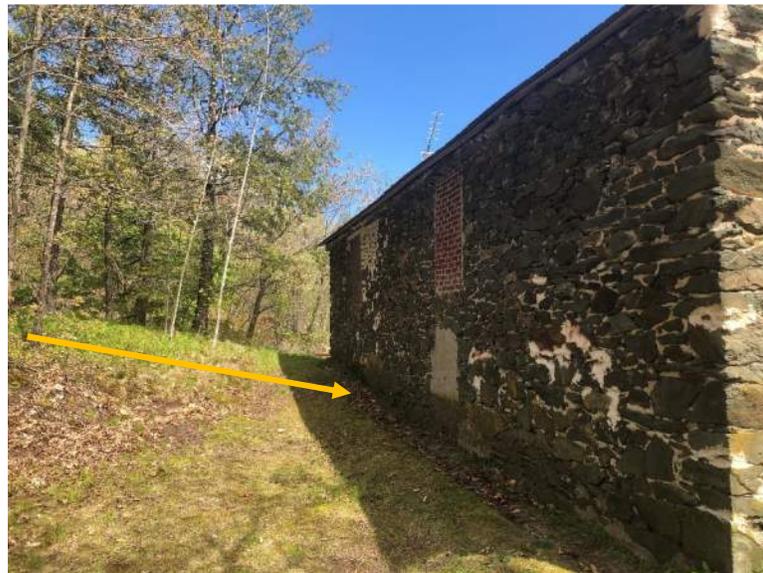
On the north and south elevations, the existing grade slopes parallel to the exterior walls toward the east. On the east elevation, the existing grade is relatively level. On the west elevation, the existing grade gently slopes parallel to the exterior wall from north to south; perpendicular to the wall, the existing grade slopes toward the building, directing water toward the building (Photo 26).

Photo 26: Exterior grade slopes toward the west wall of the building (arrow), where water seepage is occurring through the natural ledge outcropping at the interior
