ECHO BRIDGE SAFETY IMPROVEMENT PROGRAM
MWRA CONTRACT No. 6988
TASK ORDER No. (18)

Historic Cast Iron and Steel Railings Report
Newton Upper Falls – Needham, Massachusetts
Prepared for the Massachusetts Water Resources Authority

September 2007

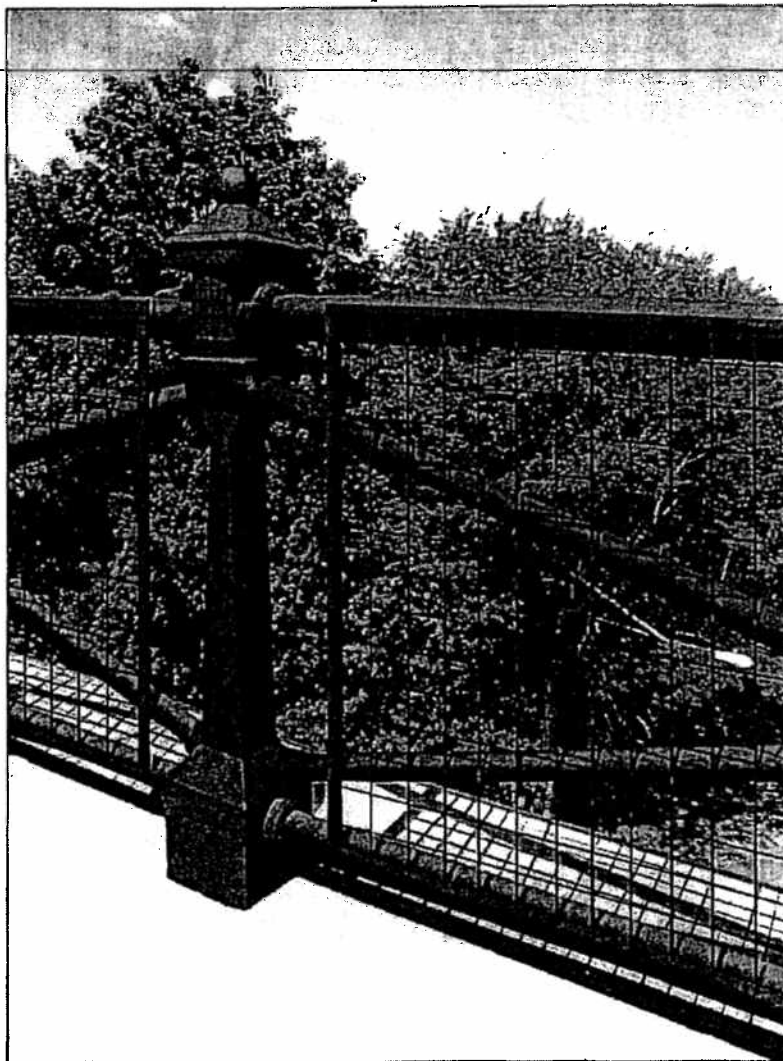
Alternative Number One: View from Bridge.
(See additional Photo on Page 15)

Directly attach a 7 feet by 3 feet framed panel of painted 2-inch stainless steel wire mesh to the historic railing system. To visually separate this panel from the historic cast iron posts, it would be kept approximately 3 inches away from each post. Painted stainless steel is recommended for these panels since pre-galvanized mesh will rust where welded to the framing and the panel is too light to galvanize after assembly.

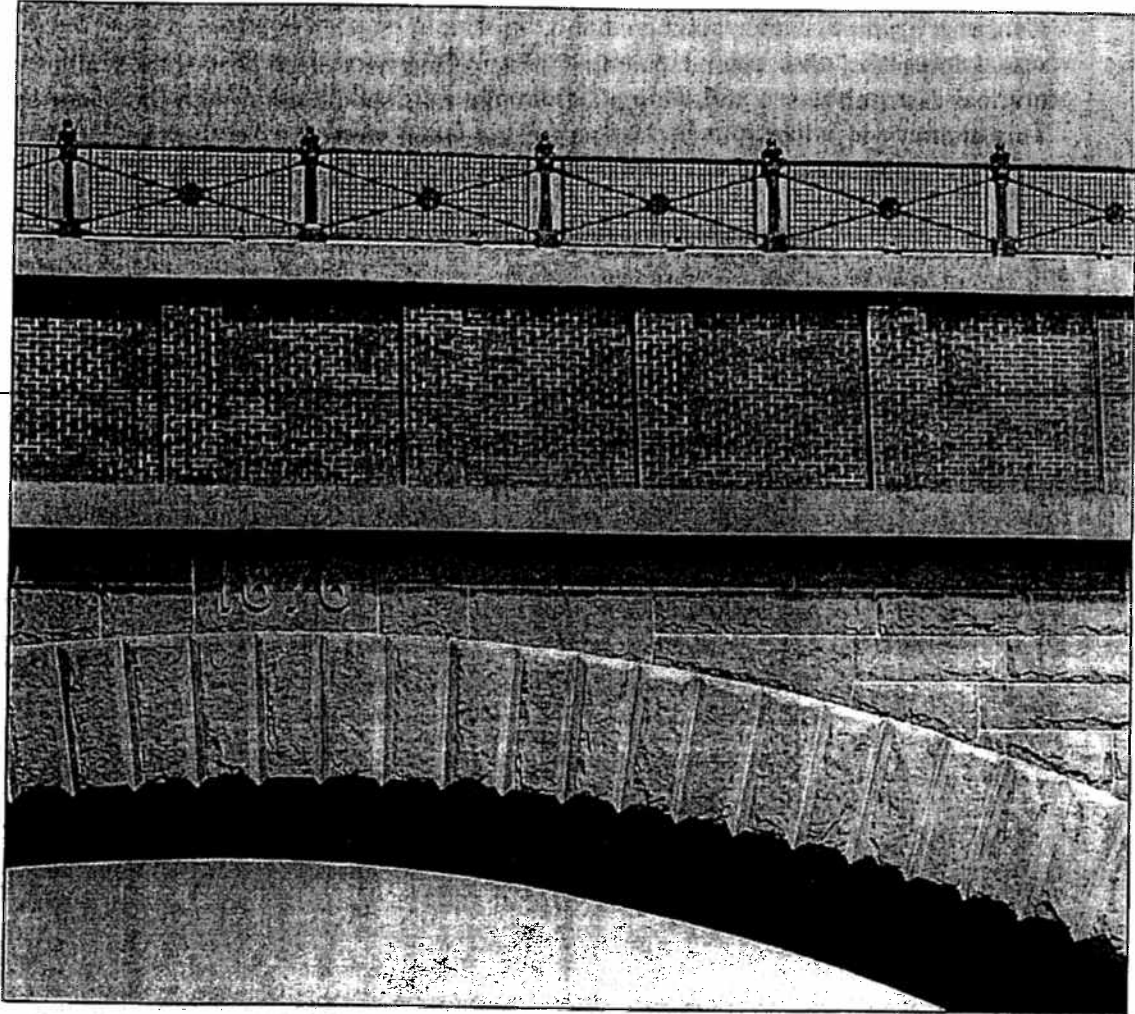
Alternative Number One: View from Charles River

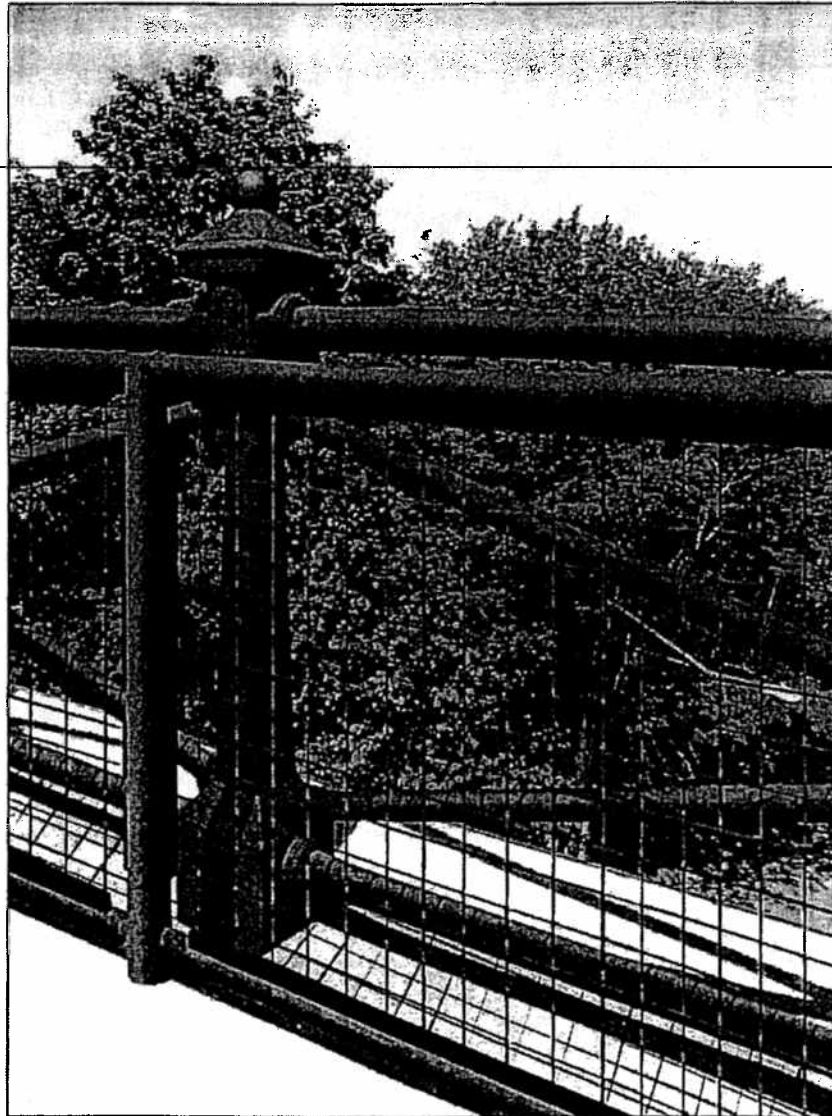
*Alternative Number Two: View from Bridge.
See additional Photo on page 17*

Construct a simple independent guardrail attached to the concrete bridge deck. To reduce the visual impact of this second guardrail system, the new steel post should align with the original cast iron posts, and the top and bottom rails should align with the historic railings. This alternative is likely to be less noticeable when viewed from the two DCR parks but more noticeable when viewed from the high deck.

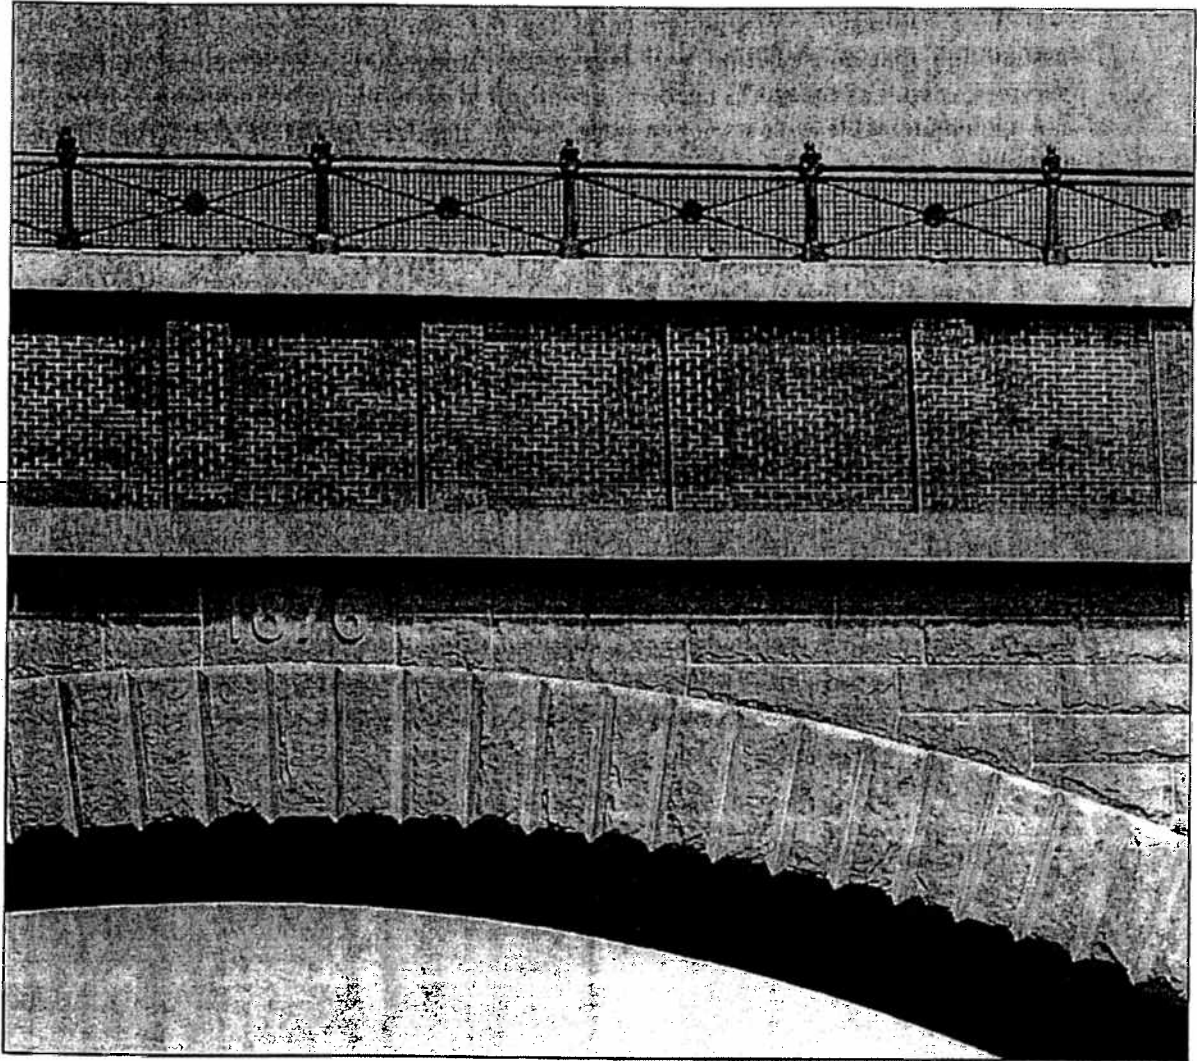
Alternative Number Two: View from Charles River

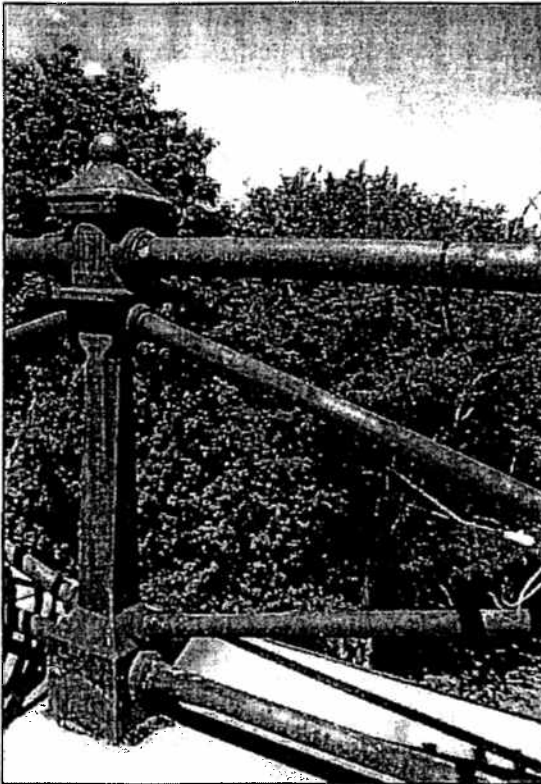
Historic Bridge Post and Railing

Both the bridge and landing posts are a one piece iron casting. Traditional "gray" cast iron is very strong in compression but much weaker in tension because of the carbon it absorbs during production. The wall thickness of the cast iron post varies from ¼ inch to ½ inch. This lack of quality control during casting and the resulting **thinned walls have made** the posts less durable to corrosion and weaker in strength than they would be able to if all walls were of a uniform ½

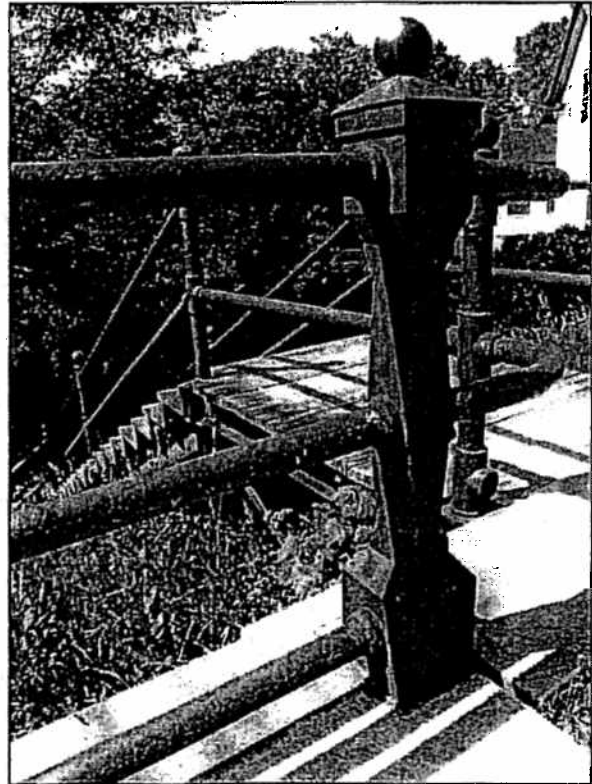
Historic Landing Post and Railing

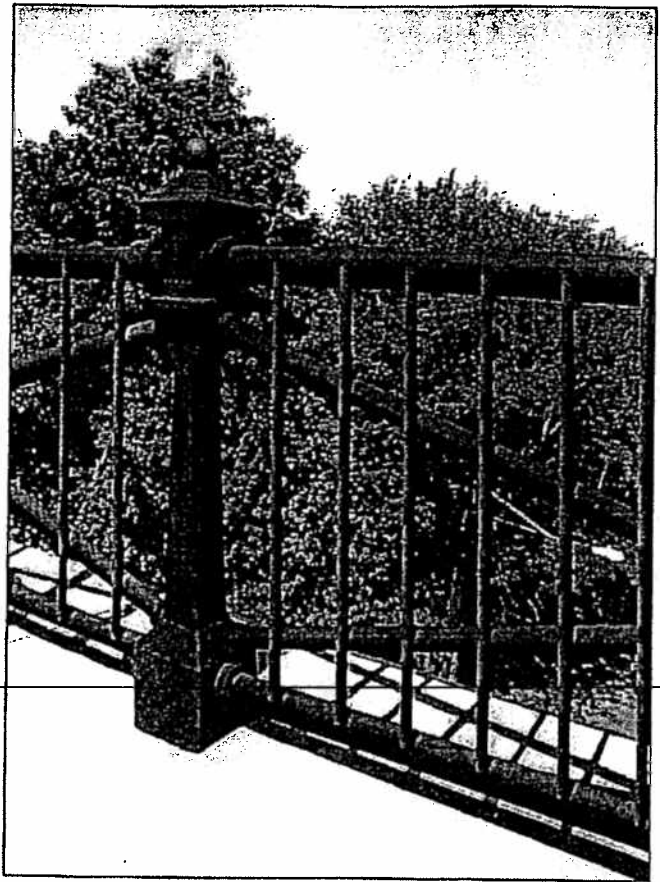
*Design "1a":
Vertical Bar Design,
View From Bridge*

Design "1a" resolves the safety issues by installing 1/2" diameter vertical galvanized steel bars at 4" on center between the upper and lower rails. This design introduces a vertical element that contrast with the existing horizontal railing system. Alternative One, Vertical Bar Design, would be comparable in cost to Alternative One or \$1,045,000.

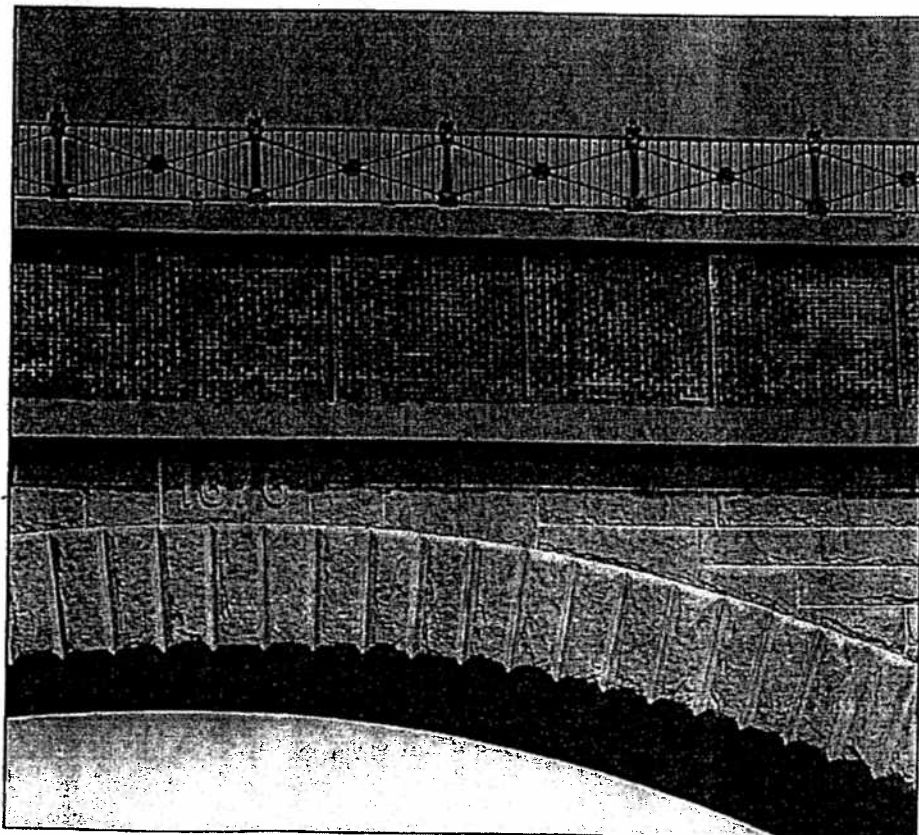
*Design "1a":
Vertical Bar Design,
View From Charles River*

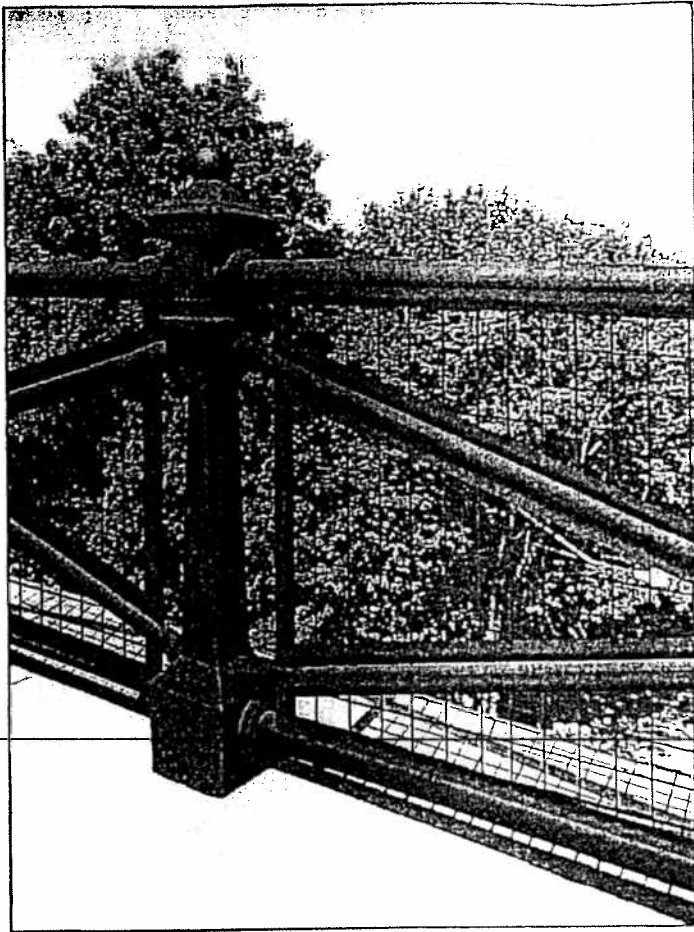
*Design "1b":
Recessed Mesh Panels,
View From Bridge*

Design "1b" resolves the safety issue by installing 2"x2" stainless steel mesh panels between the triangular shaped openings formed by the railings. This design clearly delineates the geometry of the original historic structure. Design "1b", Recessed Mesh Panels, would be approximately five percent more expensive than alternative One or \$1,098,000.

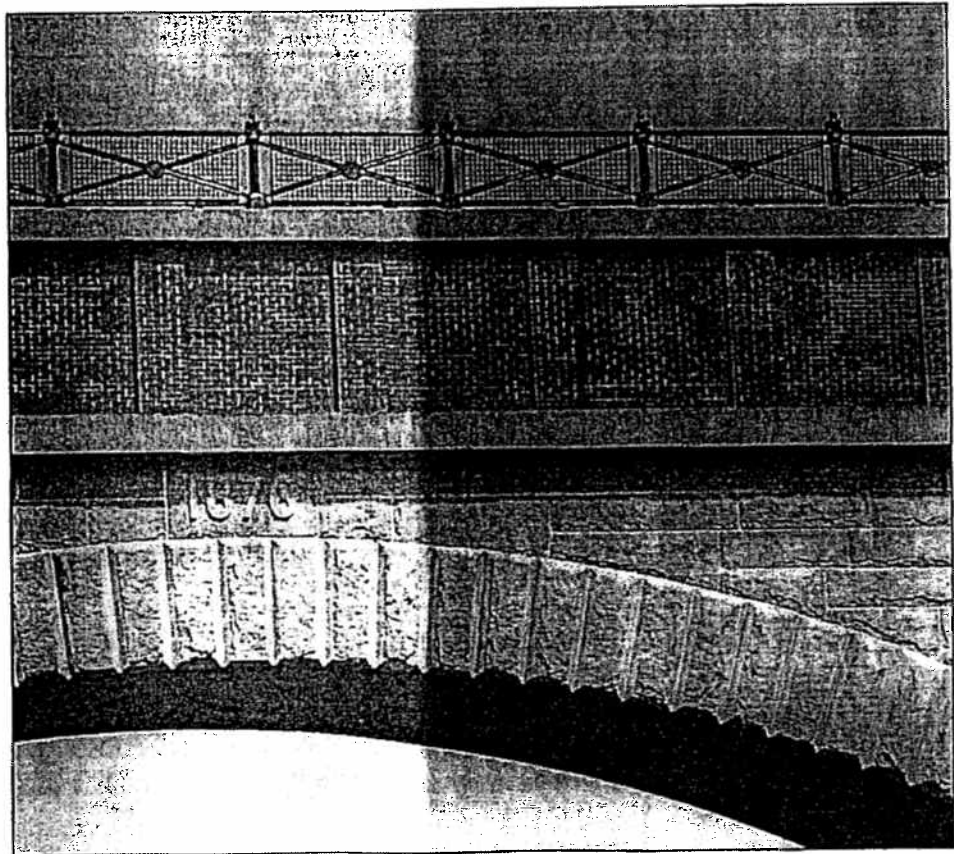
*Design "1b":
Recessed Mesh Panels,
View From Charles River*
